Xerox scanners found to sometimes alter numbers

Martyn Williams, IDG News Service
[@martyn_williams](#)

Aug 6, 2013 10:25 AM

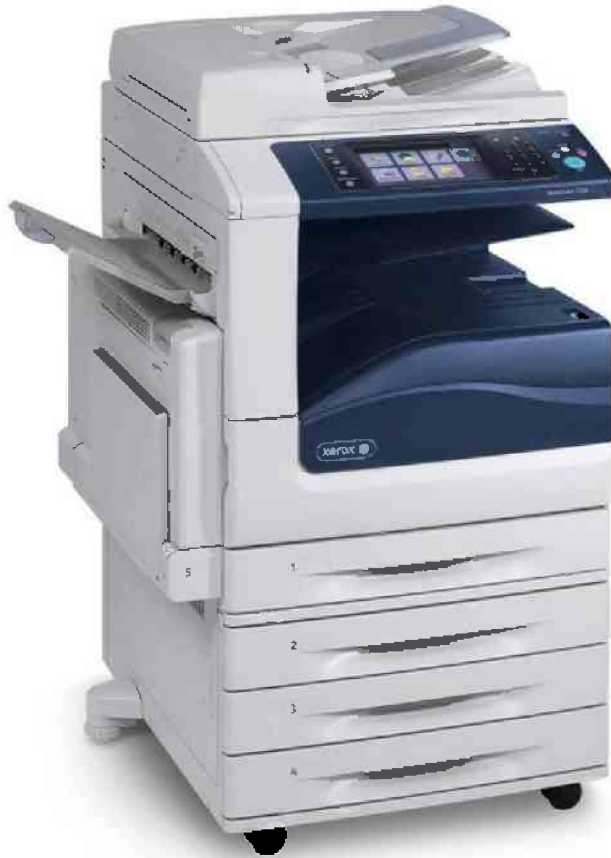
A Xerox WorkCentre 7535 (shown above) reproduced an image where every room was labeled 14.13m² in area. The same thing happened on a Xerox WorkCentre 7556 on one scan. A second scan on the same machine had two rooms at 17.42m² and one at 21.11m² and a third scan produced two rooms labeled 14.13m² and one at 17.42m².
